Bearing Carrier Nut Low Torque – 60 Bigfoot, 75 thru 125

Models Affected

1997 60 HP Big Foot

1997 75 thru 125

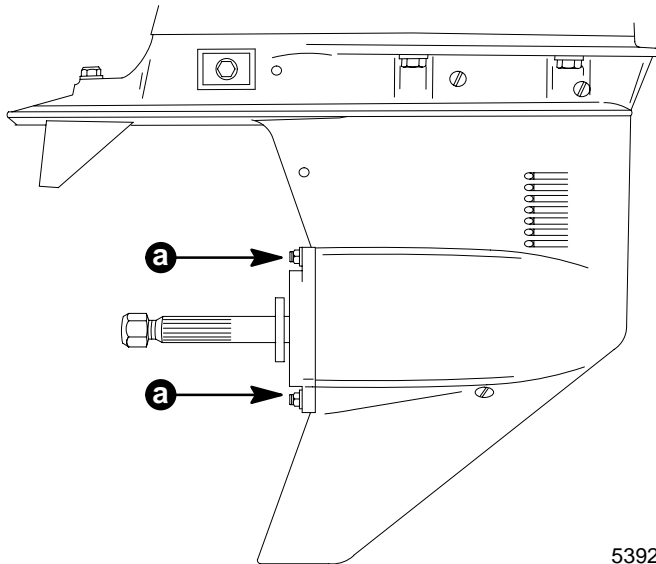
A small quantity of bearing carrier nuts on the models listed were torqued below specification during assembly. On these models, the bearing carrier may become loose and eventually fail the gearcase. It is necessary to retorque the bearing carrier nuts to the specified torque of 25 lb. ft. (33.9 N·m).

a - Nut Torque 25 lb. ft. (33.9 N·m)

Loosen each bearing carrier nut, one quarter turn, and retorque to 25 lb. ft. (33.9 N·m). Paint the end of the stud/nut white for repair identification.
