Obstructed Fuel Line Connector – Mariner/Mercury 8-200 Models

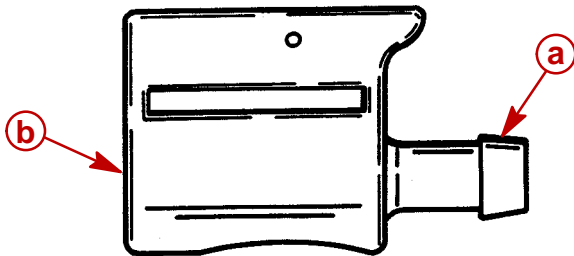
Figure 1. Fuel Line Connector P/N 22-13563A3 50943

Fuel line connector P/N 22-13563A3 may have excess plastic in the fuel passageway inside the housing. Excess plastic may prevent full coupling of the fuel line to the outboard fuel connector and/or restrict fuel flow to the engine. Outboards and service stock listed require inspection of fuel line connector.

- a - Fuel Line End
- b - Brass Piece in End

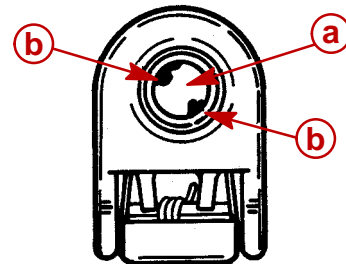
Figure 3. Obstructed Fuel Connector 50943

Inspect for excess plastic in passageway by looking into connector from fuel line barbed end. Brass piece on opposite end of connector should be fully visible. If brass piece is not visible, the connector is defective and must be replaced.

- a - Brass Piece Partially Visible
- b - Excess Plastic in Passageway
