Lean Above Idle RPM – 1990 Mariner/Mercury 135

MODELS

1990	Mariner 135	S/N 0C221500 thru 0C284070
1990	Mercury 135	S/N 0C221500 thru 0C284070

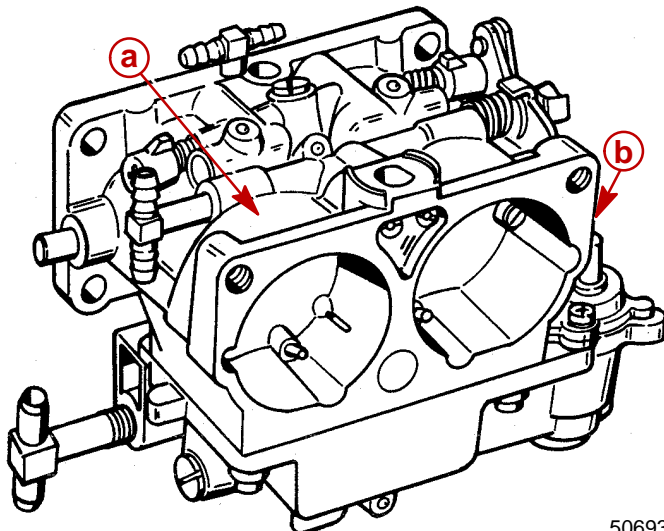
50693

- a** - Carburetor Model (WMH)
- b** - Carburetor Number (8-1, 8-2, etc.)

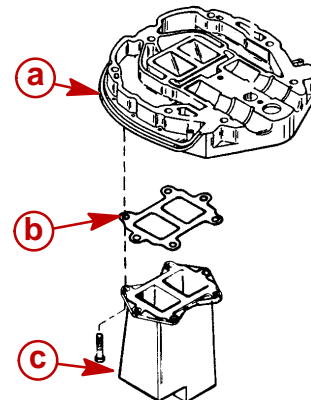
- a** - Drive Shaft Housing Plate
- b** - Gasket
- c** - Exhaust Extension

Replace exhaust extension.

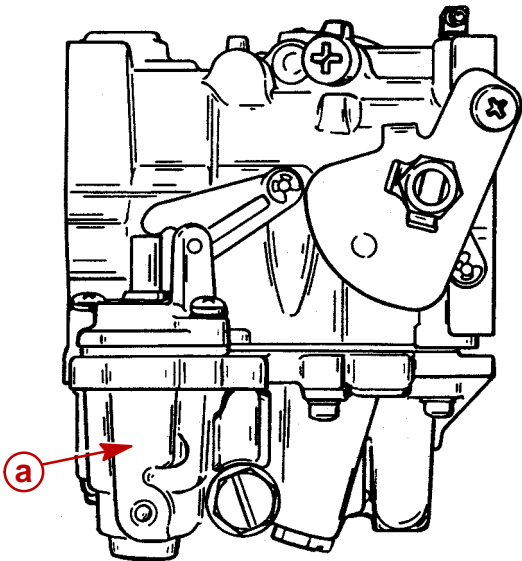
50694

a - Identify with "X"

Scribe an "X" on the side of each carburetor casting by accelerator pump.
