## Rubber Retainer-Bleed Check Valve – 1990 Mariner/Mercury 75-115

This is a revision of Outboard Service Bulletin 90-2. Destroy Bulletin 90-2 and insert Bulletin 90-2A. Revisions are underlined.

1990 Mariner and Mercury 75-115

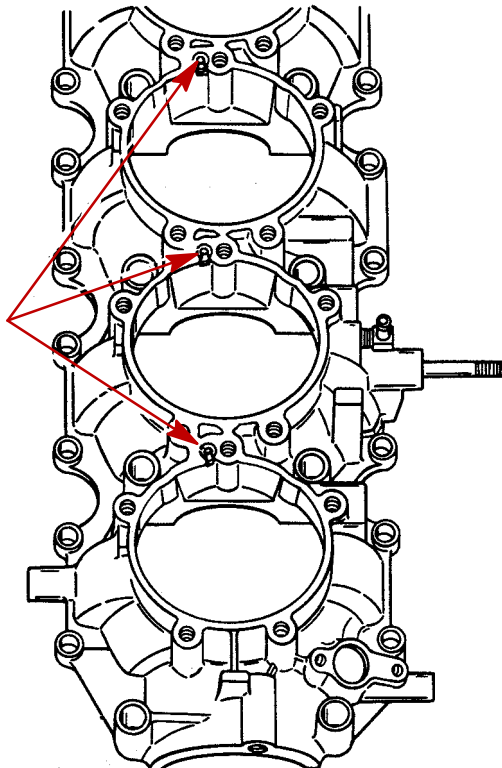
Figure 1. Bleed Check Valve Location

Rough running at idle may be caused by an improperly formed rubber retainer that holds the bleed check valve. (Figure 1) Improperly formed rubber retainers have a thin piece of rubber covering the opening (Figure 2) which prevents circulation of puddled fuel. The opening must be clear for the bleed system to operate properly. Retainers are now inspected before installation in the engine after serial numbers listed.

Carefully remove excess rubber material that is covering the opening. Replacement is not necessary.

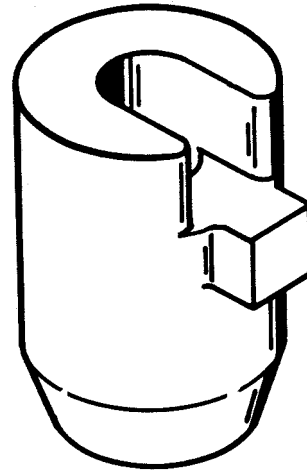
Figure 2. Rubber Retainer-Bleed Check Valve

**a** - Opening
