Overheating - 1988 Sea Ray 135 and 175

1988 Sea Ray 135 and 175 s/n 0B241881 thru 0C100861

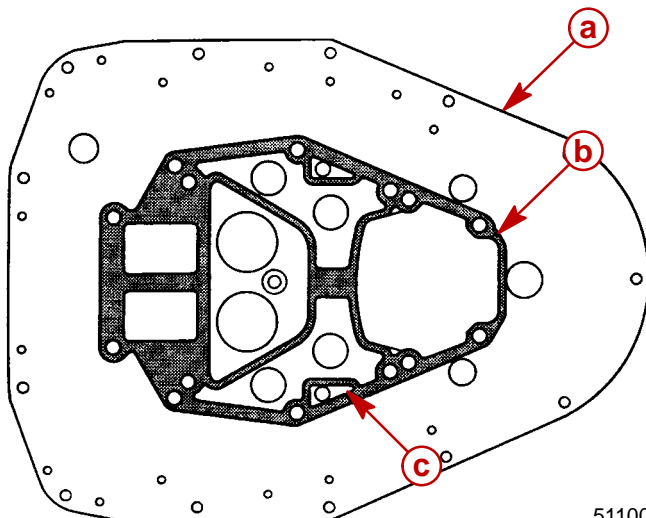
Figure 1. Top View Of Cowl Mounting Plate

Some 1988 Sea Ray V135 and V175 outboards with oyster colored bucket cowls may experience an overheating condition. This condition may occur on outboards that are operated for long periods of time at full throttle in warm water. The overheating condition may be caused by restrictive water dump hole in the cowl mounting plate p/n 18103.

- a** - Cowl Mounting Plate
- b** - Gasket
- c** - Enlarge Hole to Triangle Shape

If overheating persists, modification of the cowl mounting plate is required. Use the gasket p/n 27-99776--1 as a template and scribe the triangular water dump hole opening on to the starboard side of the plate as shown in figure 1. Open the hole to the scribed line and deburr the plate (figure 2). Reassemble with new gaskets on both sides of the plate. This modification will increase water flow and reduce water pressure at 2500 RPM from 12 psi (83 kPa) to approximately 8 psi (55kPa).

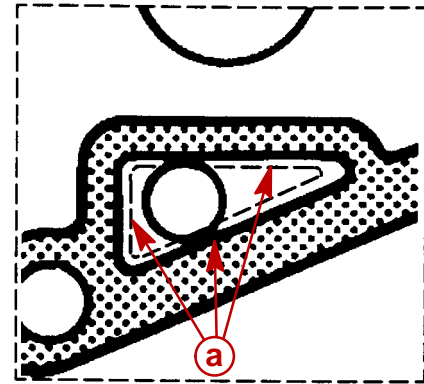
Figure 2.

- a** - Open to Edges
