Improved Manual Tilt Assist - Speed/Effort – 1991-1993 40 thru 60

MARINER AND MERCURY

Manual Tilt Assist Design III

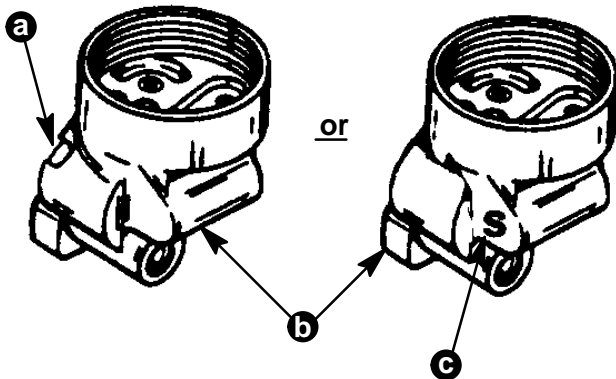
Figure 1. Design III Manual Assist Identification

- a - Upper Notch
- b - Valve Block Assembly
- c - Stamped “S”

Installation of Manual Tilt Rate Update Kit P/N 824950 on the (**Design III Only**) manual assist will improve the tilt speed/effort in cold weather climate.

An improved transfer port cover plug, spool assembly and installation instructions are included in the kit.

Also, replace the original 10W-30 oil with Quicksilver Power Trim and Steering Fluid P/N 92-90100A12.

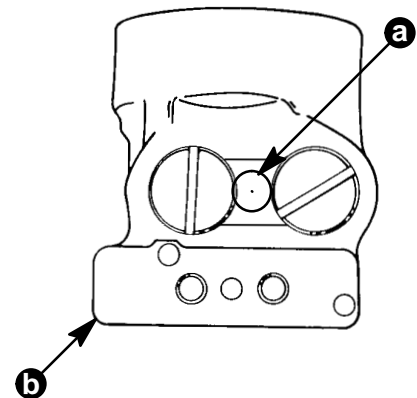
Figure 2. Design III Manual Assist Identification

Design III Valve Body Uses Plug Over Slow Trim Valve

- a - Plug Over Slow Trim Valve
- b - Valve Block Assembly
