Poppet/Relief Valve Spring – 3.0 Litre

1997 225/250 HP, 3.0 Litre

1997 225 HP Seapro/Marathon 3.0 Litre
S/N 0G438000 thru 0G518681

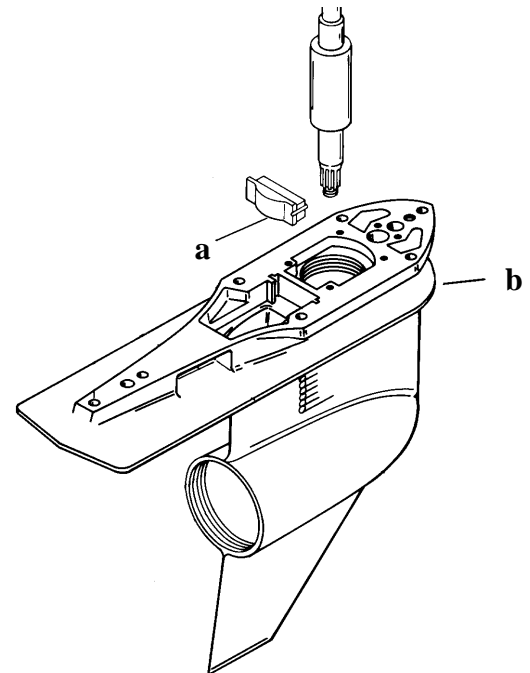
Remove the lower unit, and closely inspect the rubber filler block. If the filler block has a burnt appearance make the following correction.

- a - Filler block
- b - Gear housing

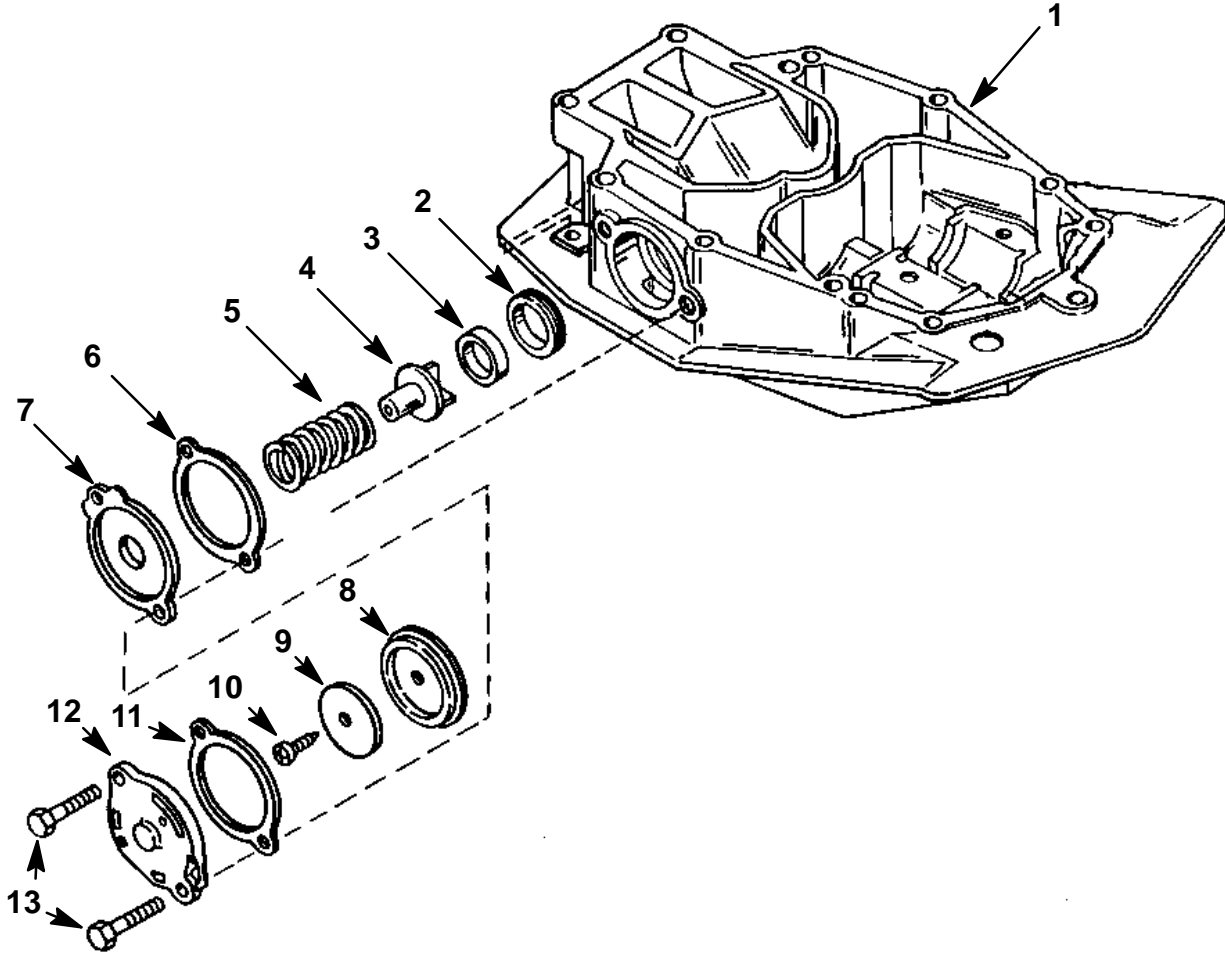
- 1 - Exhaust Plate
- 2 - Carrier
- 3 - Grommet
- 4 - Poppet/Relief Valve
- 5 - Spring
- 6 - Gasket
- 7 - Inner Plate
- 8 - Diaphragm
- 9 - Washer
- 10 - Screw
- 11 - Gasket
- 12 - Outer Cover
- 13 - Bolts [Torque bolts to 20 lb. ft. (27.0 N-m)]

Remove the bottom cowl (starboard side only).

Remove the two bolts that retain the poppet/relief valve cover to the exhaust plate.

Remove the poppet/relief valve assembly from exhaust plate.

Remove the screw that retains the valve and spring to the inner poppet/relief valve plate.

Install the new poppet/relief valve spring P/N 24-854478.

Reassemble and install poppet/relief valve assembly using 2 new gasket P/N 27-88907.
