Tempest and Trophy Propeller Flo-Torq II Bushing (A45/A46 Series)

NOTICE

Models Affected

135 thru 250 HP

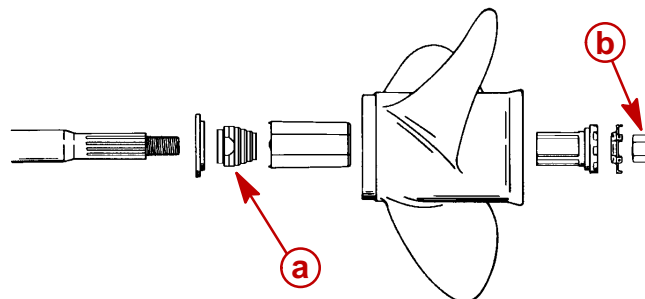
Under certain applications a Tempest or Trophy A45/A46 Series propeller may experience a loosening condition. If you encounter this problem, it is recommended that the propeller be removed and a Flo-Torq II Bushing be installed. This bushing will eliminate any propeller nut loosening.

Propeller nut loosening will cause the forward thrust hub to fret and wear on the thrust hub's taper. Continuous wear on the taper will allow the propeller to move forward and contact the gearhousing and/or the carrier retainer nut.

- a** - Bushing
- b** - 55 lb. ft. (75 N·m)

During installation of the Flo-Torq II Bushing, the forward thrust hub and the drive sleeve should be inspected for any signs of wear. Replacement of any worn parts is recommended. Torque the propeller nut to 55 lb. ft. (75 N·m).
