service bulletin

No. 98-2

Official Notification Federal Boat Safety Act Over Torque of Flywheel Bolt - 20/25 (2-Stroke) & 20 Jet

1998 20/25 (2-Stroke) & 20 Jet

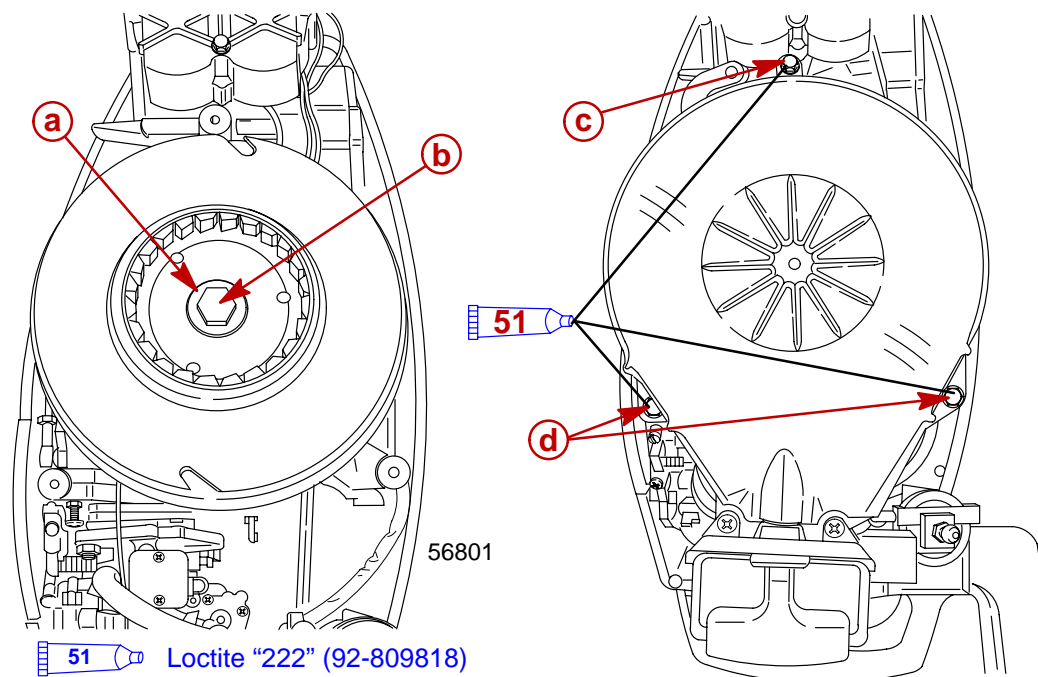
The outboards listed, may have been assembled with a torque level on the flywheel bolt that is too high. The higher torque was caused by a plating change (gold in color changed to gray) on the washer under the flywheel bolt, which reduced the friction under the bolt head. The flywheel bolt could have been over stressed which can cause a fracture, resulting in the possible loss of the flywheel. These units **MUST HAVE** both the flywheel bolt and washer replaced prior to operation.

- a - Washer
- b - Flywheel Bolt
- c - Bolts - M6x35
- d - Bolt (2) M5x20

Flywheel washers (P/N 12-86496) may be of mixed stock (Gold or Gray) and both are serviceable when the flywheel bolt is torqued to the new specification of 50 lb. ft. (67.8 N·m).

1. Remove manual starter. Remove and discard flywheel bolt and washer.
2. Secure flywheel using new flywheel bolt/new washer. Torque bolt to 50 lb. ft. (67.8 N·m).
3. Re-Install manual starter. Apply Loctite 222 (p/n 92-809818) to threads of (3) mounting bolts and torque bolts to 110 lb. in. (12.4 N·m).
