## High Oil Consumption – 3.0 Litre EFI V6

MERCURY/MARINER  
1995 thru 1998, 3.0 Litre EFI V6  
S/N 0G129222 thru S/N 0G760300

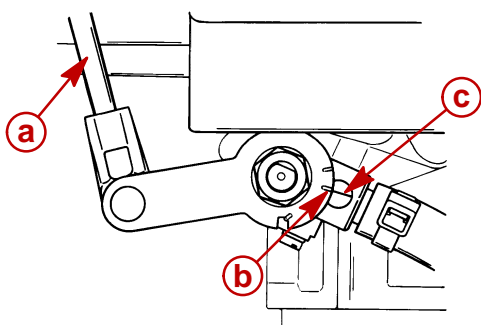
#### Standard Setting

- a** - Link Rod
- b** - Alignment Mark
- c** - Casting Mark

When an engine comes in for service, or before being sold inspect the engine for standard oil link rod adjustment as outlined in section 2C of service manual (P/N 90-822900R3). Removing the port lower cowl and shift anchor assembly will be necessary to check for proper oil pump cam location. Once the standard setting has been made, lengthen the oil link rod 3 full turns. This new setting will correct the oil link rod geometry, and should improve the oil consumption.
