ADVISORY  
 BULLETIN

No. 99-6

## End Cap OptiMax Air Compressor

135/150 HP, 2.5 LITRE OPTIMAX  
S/N 0G868674 Thru 0G925496

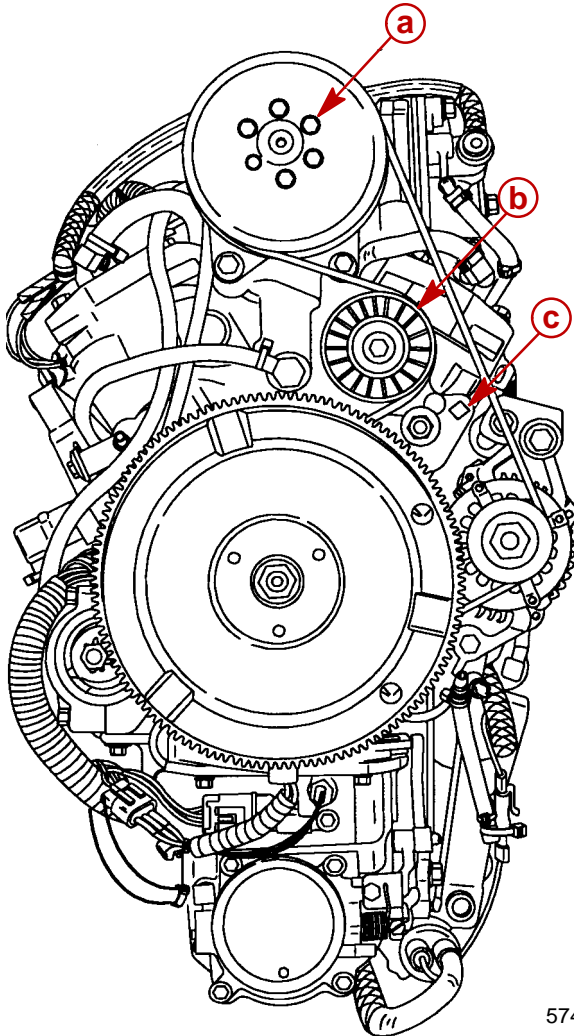
### 2.5 Liter

- a** - Pulley retaining bolts (5)
- b** - Tensioner
- c** - 3/8 (9.5 mm) square drive

- Remove flywheel cover
- Use 3/8-inch (9.5 mm) drive on belt tensioner arm to relieve belt tension, and remove belt.
- Remove the 5 bolts that retain the pulley to the pulley flange.

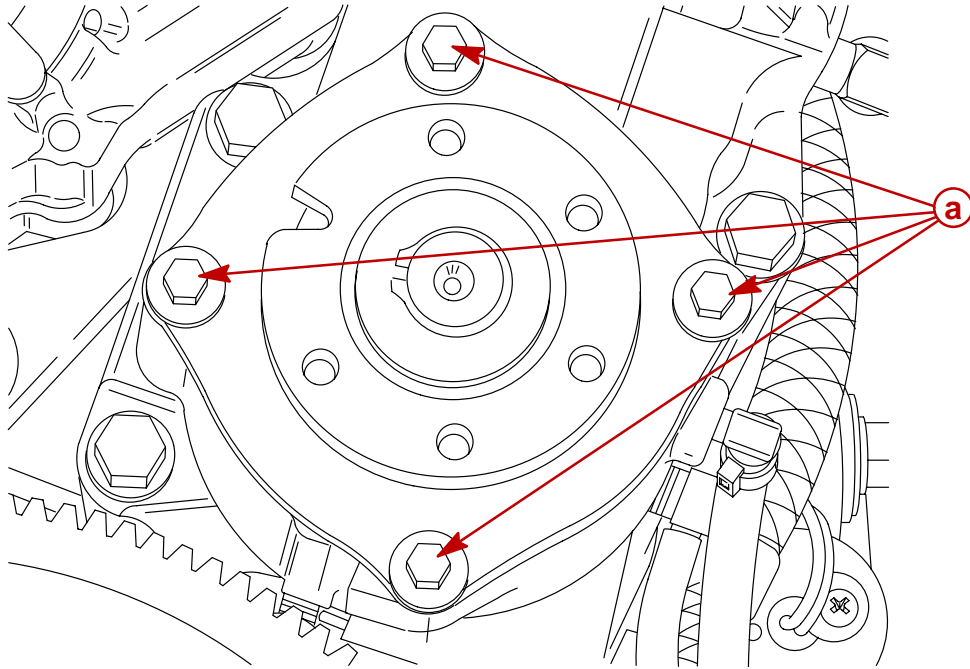
**a** - End cap retaining bolts (4)

- Remove the 4 bolts that retain the end cap to the compressor body.

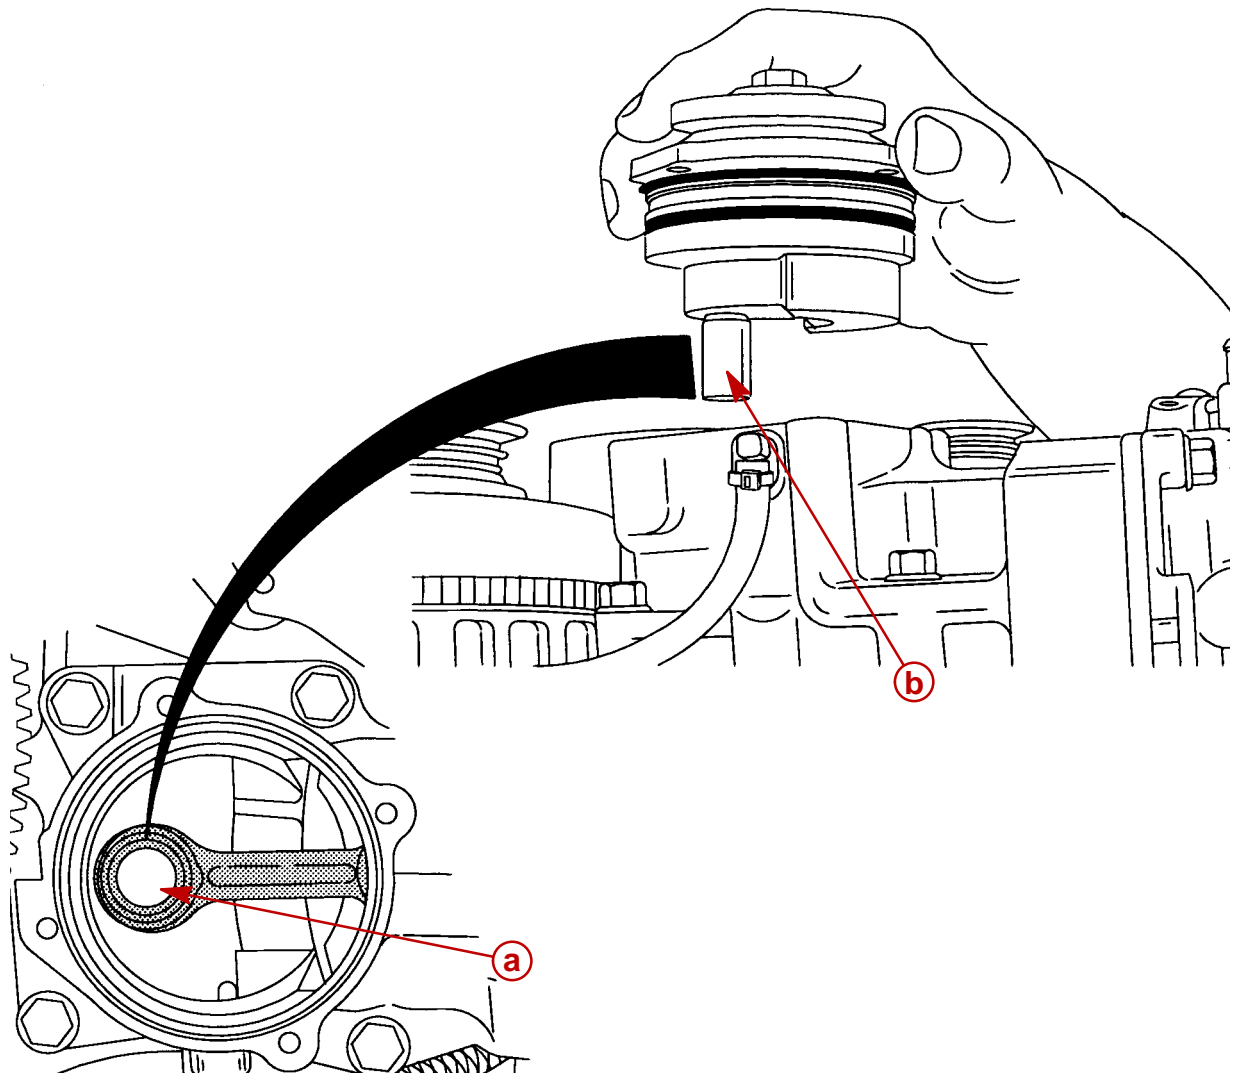
- a** - Connecting rod open end
- b** - Crankshaft connecting rod Journal

- Lubricate end cap O-ring and O-ring contact area in compressor body with two cycle oil.
- Slide the new end cap assembly into the compressor body, keeping the connecting rod journal lined up with the open end of the connecting rod, until the crankshaft just enters the open end of the connecting rod.
