NUMBER: 80-1

## **REQUIRED Fuel System Rework on the Following 1979 Merc 4.5 Motors ONLY.**

### **1979 MERC 4.5**

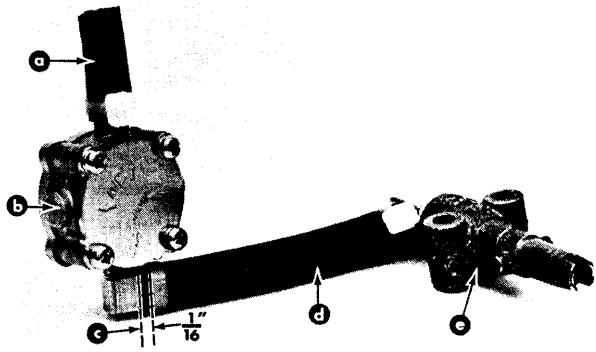
Figure 1. Fuel Pump and Lines Assembled

Mercury Marine has determined that the fuel line routing on some 1979 Merc 4.5 motors (serial numbers specified above) must be reworked to reduce the possibility of a fuel leak and prevent a potential fire hazard.

- a - 1" (25.4mm) Fuel Line
- b - Fuel Pump Assembly
- c - 1/16" (1.6mm) Maximum (4 Sta-Straps)
- d - 3" (76.2mm) Fuel Line
- e - Fuel Line Adaptor

1. Apply a small amount of Perfect Seal (C-92-34227) or equivalent pipe thread sealant to threads of 90° fitting (removed from old strainer cover) and install fitting into new strainer cover (supplied). (Figure 2)
2. Assemble new fuel pump, strainer cover, fuel line adaptor and fuel lines, as shown in Figures 1 and 2.

**IMPORTANT: "Arrows" on fuel pump indicate direction of fuel flow to carburetor. New sta-straps (supplied in kit) MUST BE USED. Make certain that fuel lines are installed all the way on the fittings and position sta-straps 1/16" (1.6mm) MAXIMUM from ends of fuel lines (pull sta-straps tight with a pliers).**

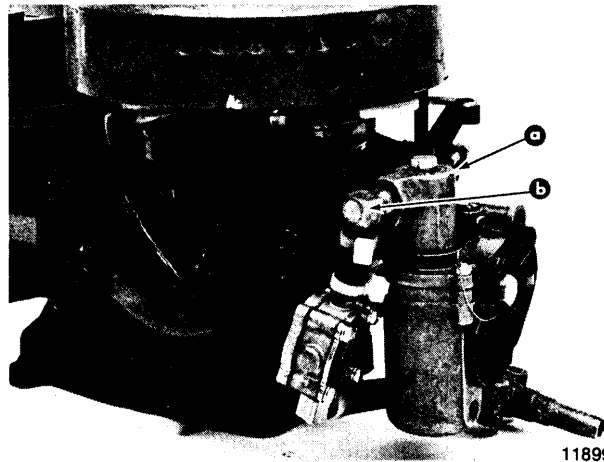
Figure 2. Fuel Pump Assembly Installed

- a - Fuel Strainer Cover
- b - 90° Fitting
