ADVISORY
 BULLETIN

No. 2001-01

Direct Injector Replacement Optimax

MERCURY/MARINER
2000 Model, 115 Thru 150 HP, 2.5 Litre Optimax
2001 Model, 135 Thru 225 HP, 2.5 and 3.0 Litre Optimax
Select Serial Number Groups

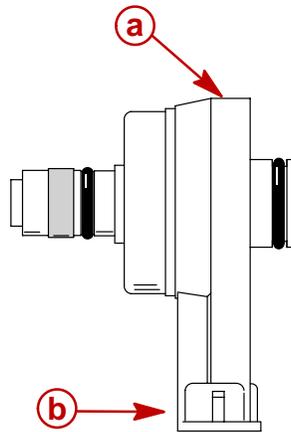
ENGINE OUT OF CARTON: Check for BLUE paint dot on the direct injector opposite the electrical connection this can be seen from the side of the engine, looking between the rail and cylinder head, or look for the plastic part of the injector to be BLUE in color. BLUE paint dot or BLUE plastic housing indicates that the engine has the latest injector, and no further action is required.

- a** - BLUE Paint Dot Location
- b** - Electrical Connection

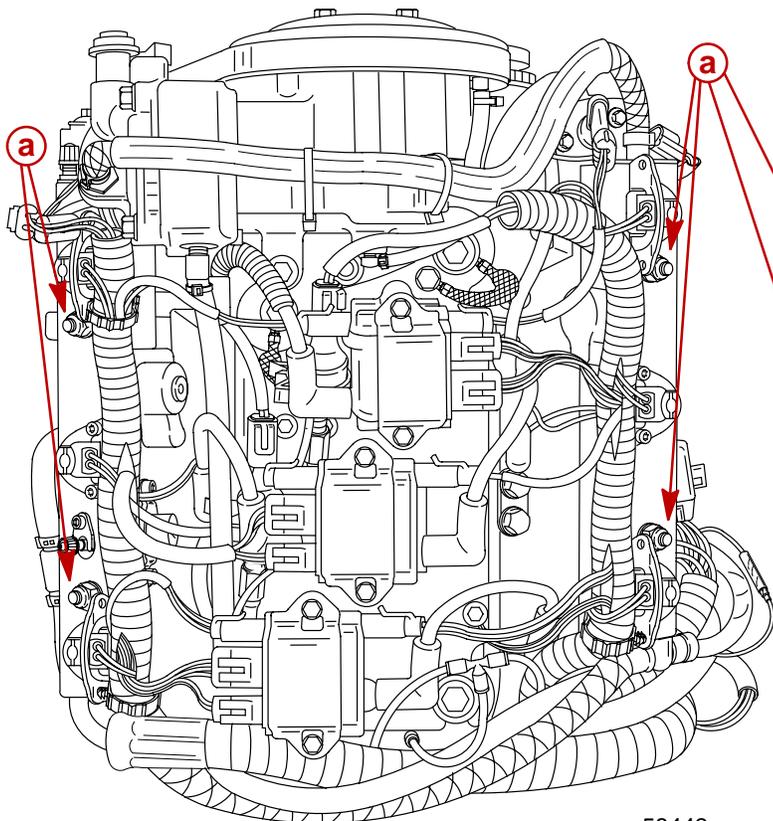
58443

135/150/175 DFI Powerhead Aft View

a - Fuel Rail Retainer Nuts

- Disconnect the battery voltage supply from engine.
- Remove the top cowl.
- Remove the two (2) nuts that retain one fuel rail.

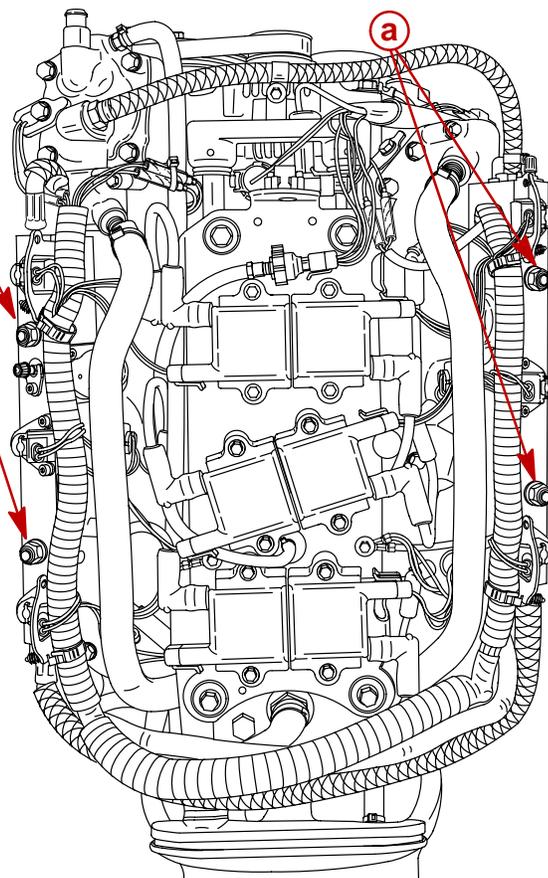
57785

200/225 DFI Powerhead Aft View

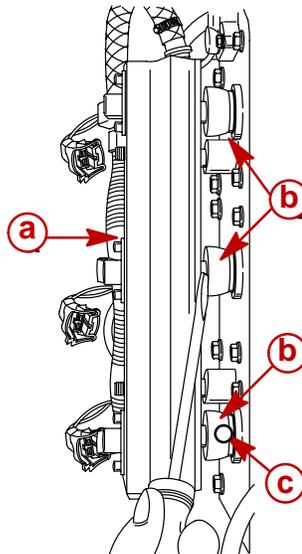
56121

- a** - Fuel Rail
- b** - Direct Injectors
- c** - BLUE PAINT DOT THIS LOCATION ON DIRECT INJECTOR

- Slide fuel rail to the rear/aft of engine until clearance to remove direct injectors is obtained.

- Pull direct injector out of cylinder head or rail.

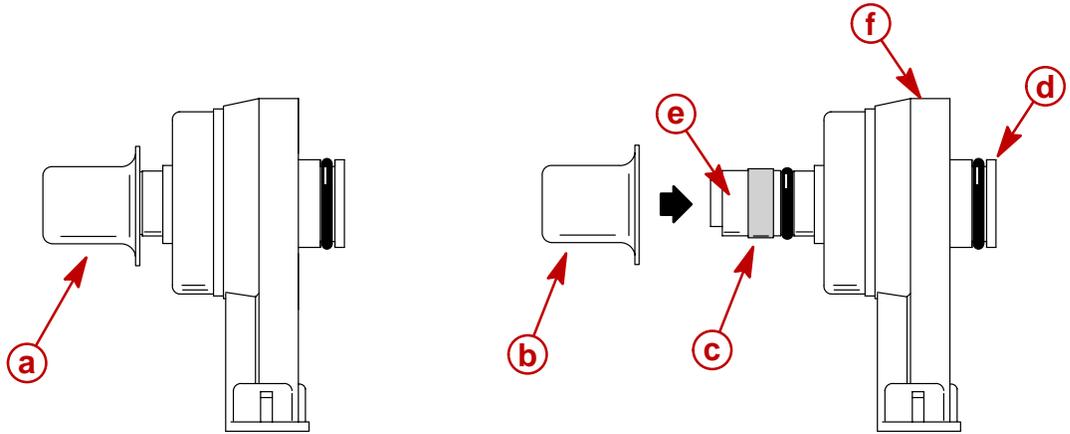
58587

- a** - Sizing Bushing Installed On Direct Injector
- b** - Sizing Bushing Removed
- c** - Teflon Seal
- d** - Rail End Of Injector
- e** - Cylinder Head End Of Injector
- f** - BLUE Paint Dot (Early Replacements)

- After the injectors have been removed, disconnect the harness from the injector.
- Remove sizing bushing from new injector P/N 883078A1, apply 4 stroke oil to the O-rings, connect to the harness, and install injector into the cylinder head, repeat this process for the three injectors on that cylinder bank. Care must be taken to position the injector electrical connection in the correct direction.

NOTE: When the sizing bushing is removed from the injector the Teflon sealing ring will start to expand. If too much time is taken to install the injectors, installation may become difficult and/or damage to the sealing ring could occur. Removal of the sizing bushings, installation of injectors, and torque of the fuel rail nuts should occur within 3 minutes.

- The injector normally can not be pushed all the way into the cylinder head by hand with the rail still on the engine. Use the rail to push the injectors into the cylinder head. Push the rail ahead until the back/aft end of the injectors have entered the openings in the rail.
- Install the two nuts that retain the rail and evenly tighten ($\frac{1}{2}$ turn at a time) keeping the rail parallel to the cylinder head. This will push the injector into the cylinder head, then torque nuts to 33 lb. ft (44Nm).
- Repeat this process for the other cylinder bank.
