3.0 Litre Driveshaft Oil Seal Carrier Kit

MERCURY/MARINER/TRACKER

All standard production 3.0 Litre Outboards using standard gear case.

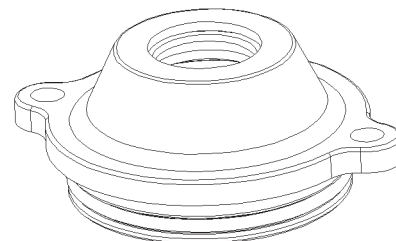
Oil Seal Carrier from Kit 840836A2

Gear case operating pressure can become excessive under certain conditions, triggering the driveshaft oil seal carrier to be pushed upward. This upward pressure bends the base plate of the water pump, which causes water pump impeller and base plate damage. Conditions that contribute to excessive pressures are overfilling of the gear case, water intrusion into the gear case, and/or elevated engine height.

Replace driveshaft oil seal carrier with kit **840836A2** if the water pump base plate is bent or the water pump impeller is damaged from excessive upward pressure from seal carrier. Water pump impeller damage caused by excessive upward seal carrier pressure will have the bottom side of the impeller near the center hub damaged/burnt.
