Service Bulletin

Bulletin No. 2008-08
OEM No. 2008-07

Official Recall Notification U.S. Federal Boat Safety Act - Shift Link 2.5 Liter

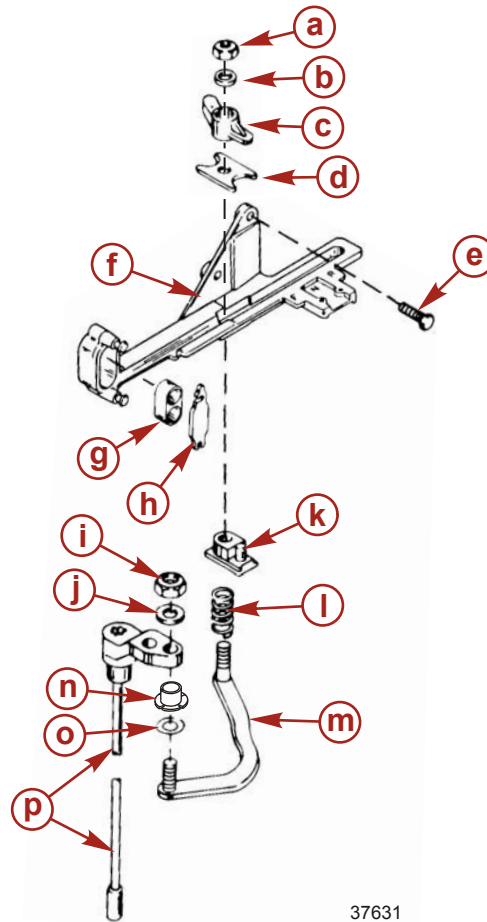
37631

Some shift links may have insufficient weld penetration between the link and shift cable and upper shift shaft attaching studs. This could result in possible stud breakage and loss of shift control.

- Remove the bushing and wave washer from the shift link and retain for reassembly.
- Reassemble in the order shown on page 2.
- Tighten the locknut that retains the shift link to the upper shift shaft assembly and back off 1/4 turn from snug.

- Install the wear plate and shift latch.
- Tighten the shift latch nut until one thread on the shift link stud is exposed above the nut.
- Mark the shift latch with a green or white paint dot to show that it has been reworked.

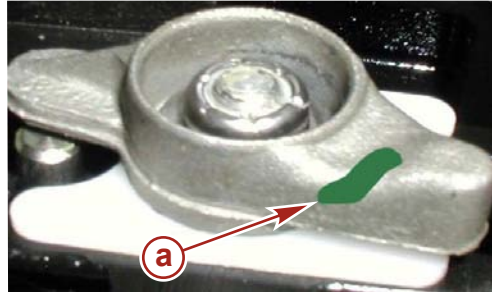
37913

If there is a green or white paint dot or mark on the shift cable latch, the engine has already been reworked. No further action is required.

a - Paint dot or mark on shift latch

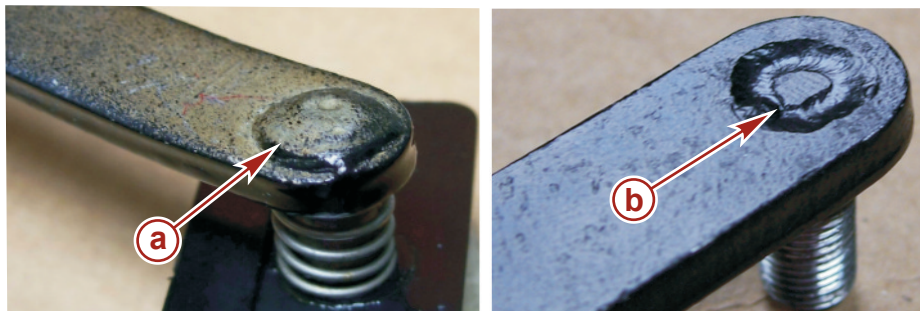
37914

a - A good weld will appear, or feel, as a raised bump directly below the stud on the bottom side of the shift link

b - A bad weld will appear, or feel, indented directly below the stud on the bottom side of the shift link

If a bad weld is found, replace the shift link using the following steps:

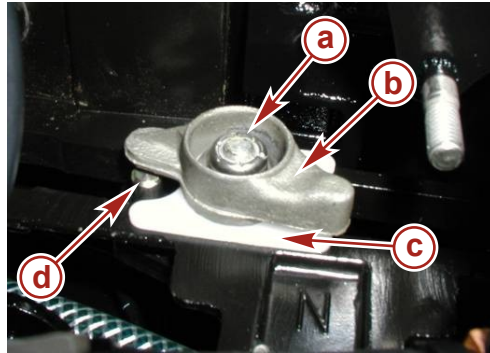
37921

- a** - Shift latch nut - one thread exposed
- b** - Shift latch

- c** - Wear plate
- d** - Guide block pin
