Joystick Piloting for Outboard System Upgrade

NOTICE
Revised July 2018. This bulletin supersedes the previous bulletin number 2016-11R3 September 2017.
<ul style="list-style-type: none"> • Reflash process changed • Warranty flat rates changed

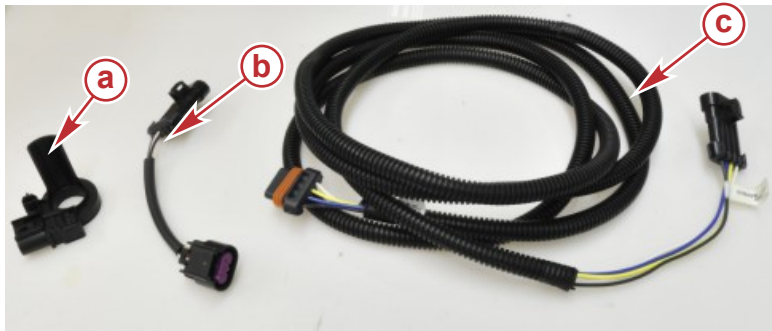
60616

Current Sensor Diagnostic Kit—8M0115125

One kit is required per power steering pump. Each kit contains the following:

Follow the installation instructions provided with the sensor kit.

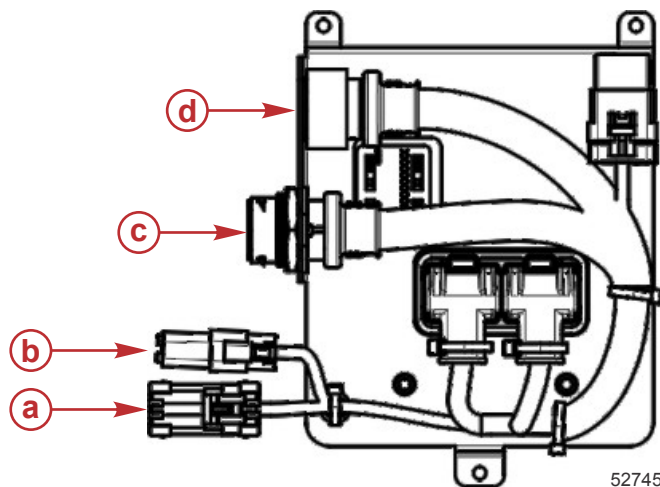
52745

TVM harnesses on units produced before August 2015 must be replaced; they do not have a current sensor connection.

TVM panel—old style, before August 2015

NOTE: There is no 4-pin current sensor connector on the old style TVM panel.

IMPORTANT: Old style harnesses must be replaced with the new style. If there was an extension harness installed between the steering actuator and the TVM it must be removed.

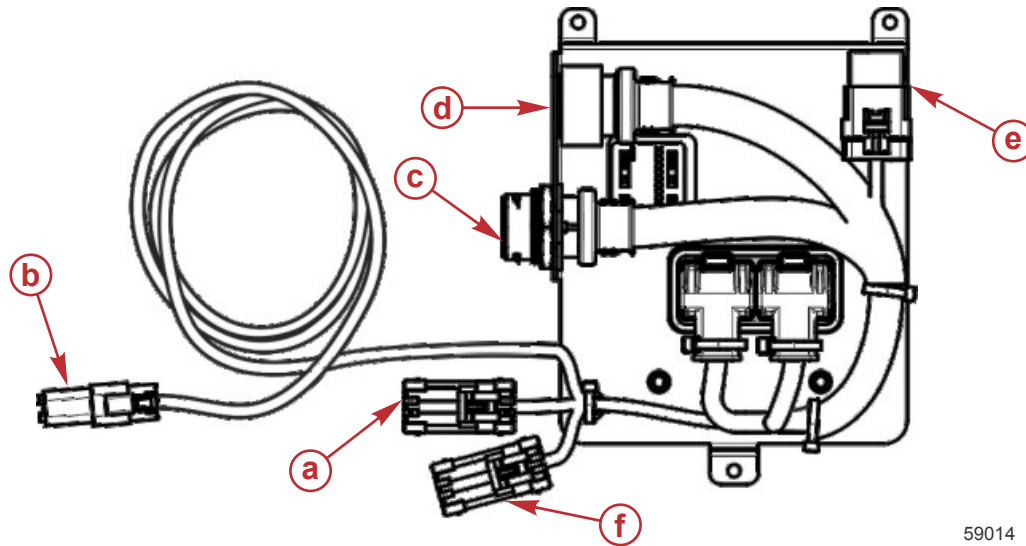
59014

TVM panel—new style, beginning August 2015
