**No. 93-21**

## A. POSSIBLE WATER LEAKAGE PAST TRANSOM MOUNTING STUDS ON ALPHA AND BRAVO TRANSOM ASSEMBLIES.

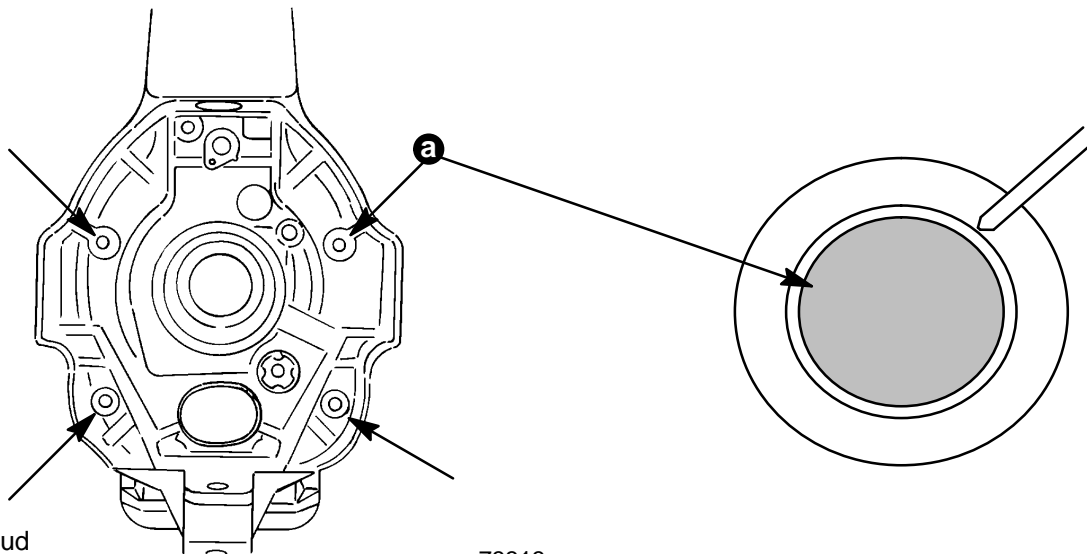
**Figure -1**

Some Alpha and Bravo transom assemblies may have been built with insufficient sealant on the threads of one or more of the transom mounting studs. Studs with insufficient sealant on the threads could allow a small amount of water to weep past the threads and enter the boat over time.

a - stud

Turn the drive as far to the starboard as possible and apply approximately two drops of sealant to the two exposed studs on the port side of the transom. Apply the sealant to the top of the threaded area so the sealant can wick around the circumference of the stud. (See figure 1.) Turn the drive to port and apply sealant to the two starboard studs.

Let the sealant cure for a minimum of three hours before putting the boat back into the water.
