service bulletin

No. 88-13

Official Notification Under the U.S. Federal Boat Safety Act

Required Spark Plug Wire Replacement

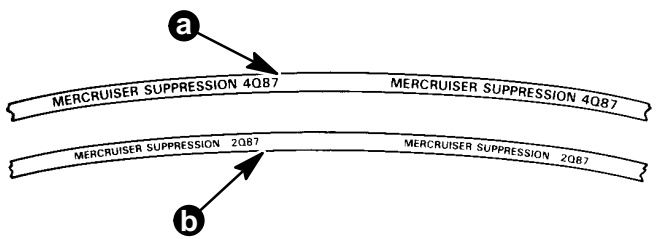
Figure 1.

Mercury Marine has determined that the spark plug wires on some MerCruiser or Sea Ray power packages (model numbers and serial numbers specified previously) must be replaced to eliminate the possibility of premature insulation breakdown, potential electrical arcing and to prevent a potential fire or explosion hazard.

Insulation breakdown only occurs in a certain brand of spark plug wire supplied to Mercury Marine by a vendor. Refer to Figure 1 for identification of the two different wires. Inspect all wires on the engine or in replacement wire sets because sets may have both types of wires in them. If (a) type wire is found, order complete new wire set for engine. Refer to chart for correct ordering information.

- a - Approximately 1/8 in. (3.0mm) High White Printing on Wire - This Type of Wire Must Be Replaced
- b - Approximately 1/16 in. (1.5mm) High White or Yellow Printing on Wire - This Type of Wire is All Right to Use

1. All owners of registered MerCruiser or Sea Ray Stern Drive or Inboard power packages that are affected by this recall: They will be sent a letter (copy attached), a campaign card (copy attached), and a set of spark plug wires for his/her engine(s). The spark plug wire set will be sent no charge to the owner of the boat and he can have any authorized dealer install the wire set on the engine(s). The owner is to sign and give the campaign card to the dealer. The dealer is to send the campaign card to his Regional Service Center for warranty payment for labor. Do not reuse old wires. Cut old wires in half and scrap.

2. Boats in dealer stock or that are sold but not registered yet: Dealer is to order correct spark plug wire set (from chart) and install on engine(s). Fill out warranty claim and send to your Regional Service Center. More than one engine can be put on each warranty claim as long as each engine model, serial number, wire set part number, and labor time is listed on one line for each engine. Cut old wires in half and scrap.

3. Replacement spark plug wire kits that were sold over the counter or installed by your dealership on customer engines: Order correct spark plug wire set (from chart). Contact all customers that you have sold these sets to. Install or exchange the old sets with the new sets. Fill out warranty claim. Send wire set(s) and claim to your Regional Service Center.

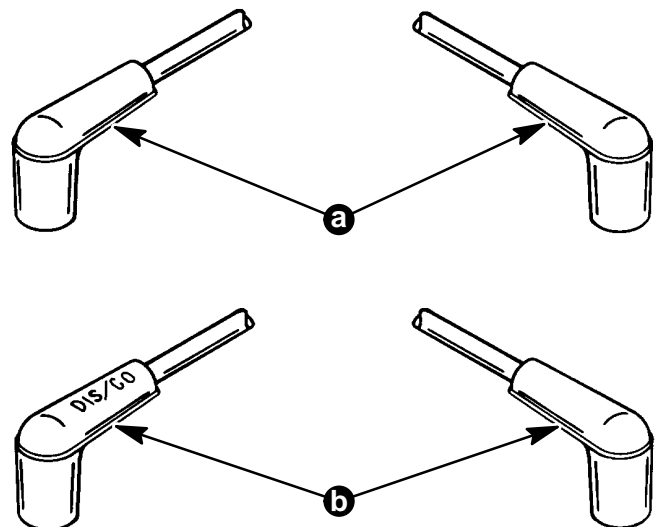
Figure 2.

- a - Thunderbolt (HEI) Wire with a Black Boot on One End and a Gray Boot on the Other End - Black Boot Must Be Installed Only on Distributor Cap
- b - Thunderbolt (HEI) Wire with DIS/CO on Black Boot on One End and Plain Gray or Black on the Other End - DIS/CO Boot Must Be Installed Only on Distributor Cap

Thunderbolt IV (HEI) spark plug wires must be installed with black or DIS/CO boot on distributor cap only. DO NOT install black or DIS/CO boot on spark plug because boot will not withstand high temperatures given off by exhaust manifold. (Figure 2)
