Official Notification U.S. Federal Boat Safety Act

496 MAG / 8.1S Fuel Line and Fuel Rail Outlet Plug Connections

Models

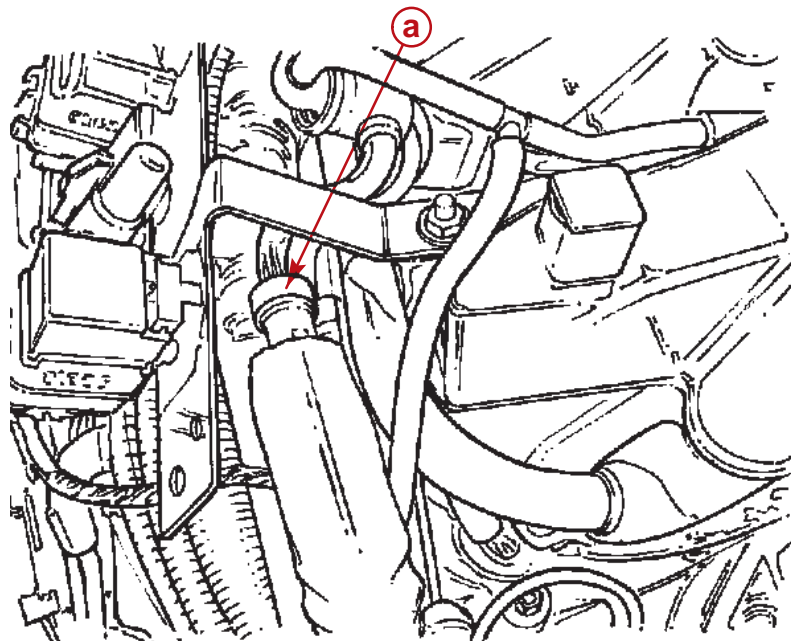
a - Fuel Line Connection

The fuel line is connected to the fuel rail on the port side of the engine (see following illustration). Follow the steps listed below to check the integrity of this connection:

1. Remove the engine cover.
2. Slide protective sleeve back on fuel line.
3. Pull on the fuel line near the connection point with an approximate force of 10 lbf. (44 N). There will be some movement due to the design of the connection. If the fuel line does not become separated from the fuel rail when force is applied, the fuel line is connected and sealed properly.
4. If the fuel line does become separated from the fuel rail, reassemble by pushing the fuel line on the fuel rail until a “click” is heard and the requirements in step 3 above for checking the integrity of the connection are satisfied.
5. When all steps have been completed, check for any leaks at this connection.

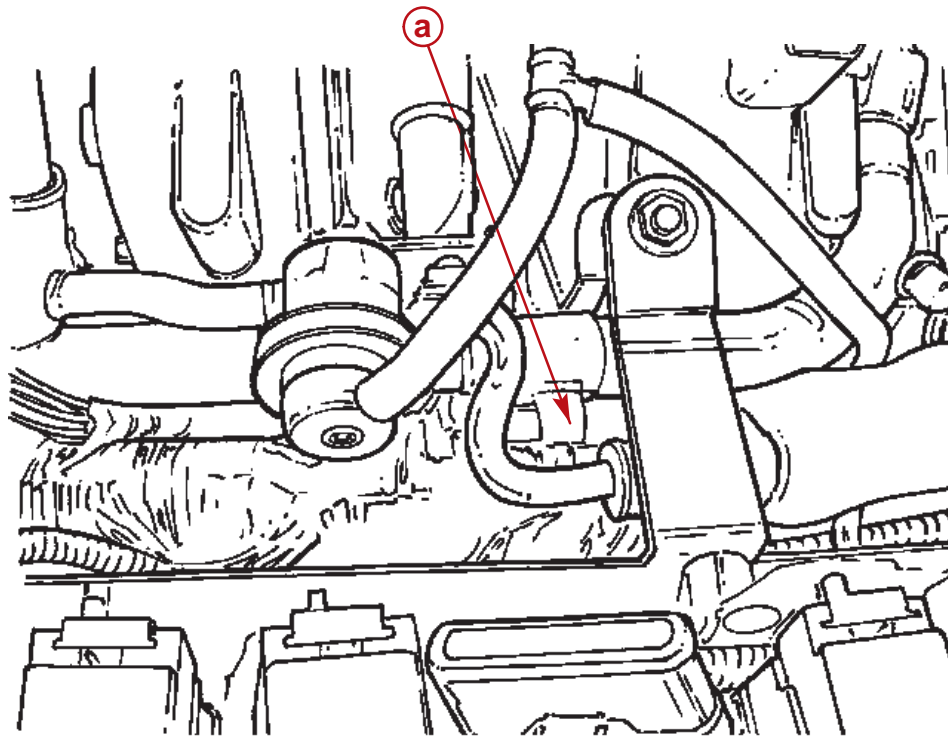
a - Fuel Rail Outlet Plug Connection

The fuel rail outlet plug must also be inspected. This plug is also connected to the fuel rail on the rear port side of the engine, above the intake manifold and below the fuel line connection (see following illustration). Follow the steps listed below to check the integrity of this connection:

1. Remove the 3-1/2 in. (89 mm) long protective sleeve from the fuel rail outlet plug.
2. Using pliers on the flat surface of the plug, pull on the outlet plug near the connection point with an approximate force of 10 lbf. (44 N). There will be some movement due to the design of the connection. If the outlet plug does not become separated from the fuel rail when force is applied, the outlet plug is connected and sealed properly.
3. If the outlet plug does become separated from the fuel rail, reassemble by pushing the outlet plug on the fuel rail until a “click” is heard and the requirements in step 2 above for checking the integrity of the connection are satisfied.

4. When the inspection is complete check for any leaks at this connection.
5. The protective sleeve must be replaced on the fuel rail outlet plug.
6. Replace engine cover.
