## Small Block V8 Oil Pan Gasket and Rear Main Seal Oil Leak

### Models Affected

Models Covered	Serial Number
5.0L Sterndrive	1A608864–1A658879
350 MAG Sterndrive	1A619042–1A658680
377 MAG Sterndrive	1A615026–1A658555
5.7L Horizon MIE	1A091381–1A093135
6.2L Horizon MIE	1A092679–1A093162
5.7L Tow Sports	1A092739–1A093154
350 Scorpion Tow Sports	1A092710–1A093144
377 Scorpion Tow Sports	1A092733–1A093100

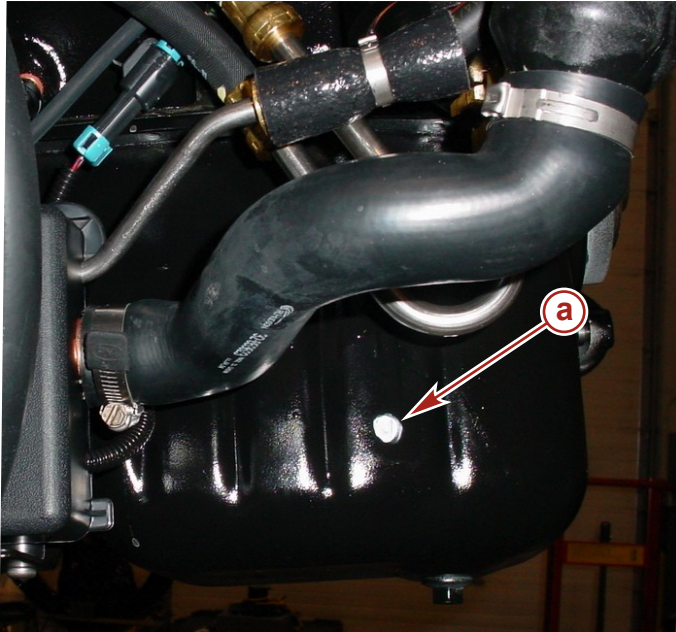
49805

Engines may have been repaired at the factory. These engines will be identified with a white paint mark on the port side of the oil pan.

a - Paint mark

After the repairs have been completed, place a white paint mark on the port side of the oil pan. Reference the picture in the **Inspection** section of this bulletin for paint mark location.

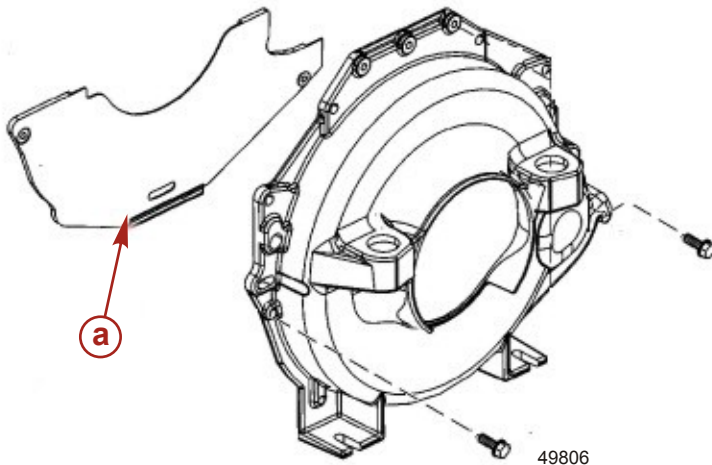
49806

Remove the lower dust shield from the bell housing. There are two 1/4" bolts that hold the dust shield in place.

a - Dust shield

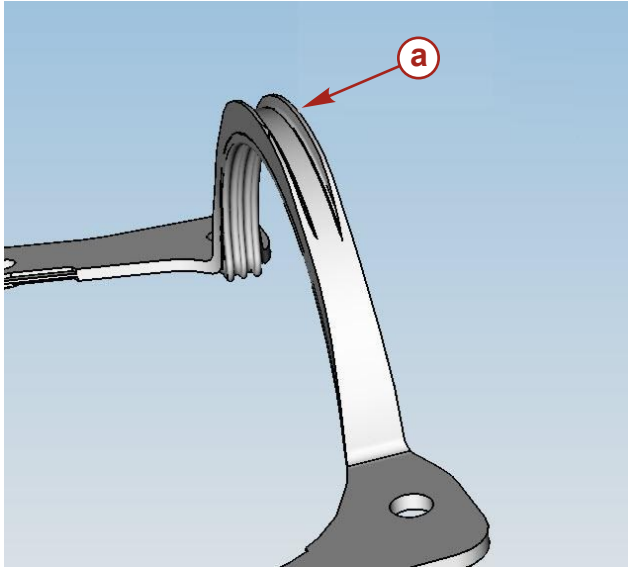
49807

Using a suitable viewing device (mirror or bore scope), look from the bottom up at the oil pan interface with the rear main seal carrier. The oil pan gasket is gray in color and has a lip that should be visible behind the oil pan edge. If no gasket material is visible, proceed to the **Correction** section of this bulletin.

a - Gasket lip

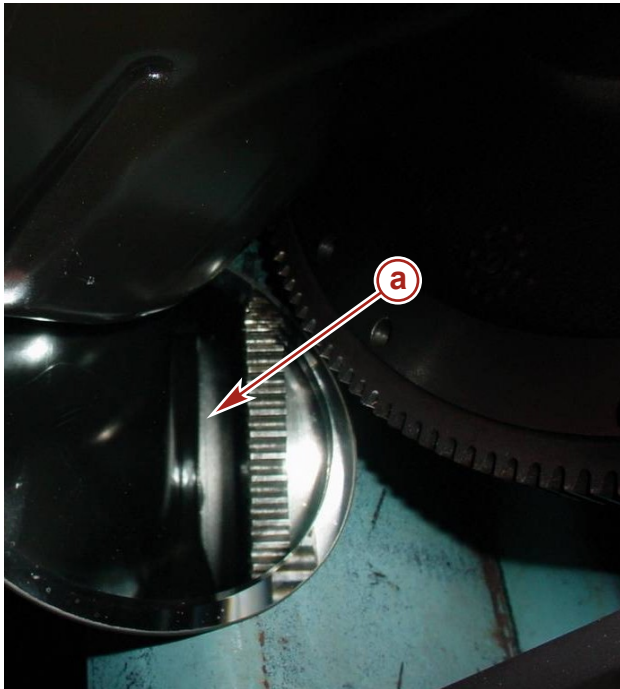
49808

The oil leak is caused by the oil pan gasket not installed correctly. The oil pan gasket can distort the rear main seal carrier, causing the leak to occur from the gasket area and/or the rear main seal.

a - Gray gasket material is not visible. This gasket is not installed properly.

The oil pan gasket and rear main seal carrier will require replacement. Follow the procedure outlined in the appropriate service manual.

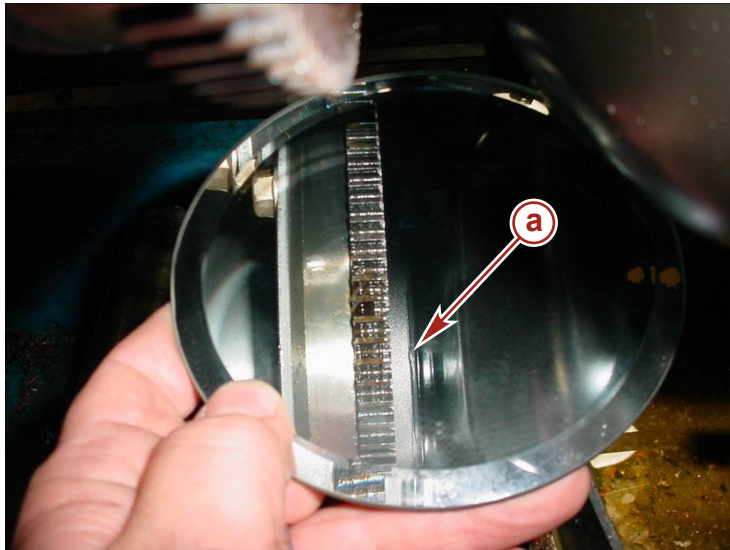
49809

**a** - Gray gasket lip is visible. This is a properly installed gasket.

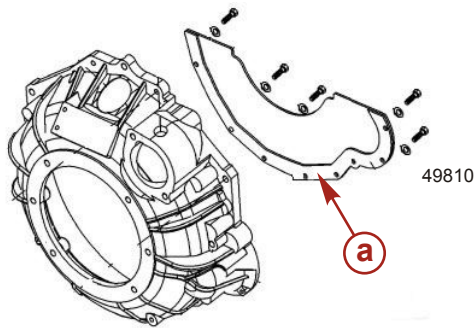
Engine removal may be necessary to remove the dust shield for inspection. There are eight 1/4" bolts that hold the dust shield in place.

**a** - Dust shield
