Official Recall Notification U.S. Federal Boat Safety Act

400R Steering Head Screw Torque Inspection

Models Covered	Serial Number Range
L6 Verado 400R	2B404572-2B443379

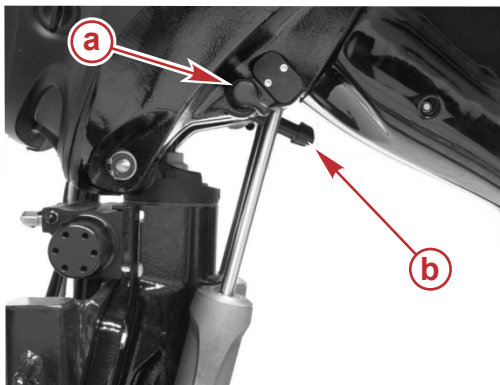
63385

- a** - Tilt lock lever disengaged
- b** - Tilt lock bracket disengaged

1. Tilt the engine to its maximum tilt, leave the tilt lock disengaged for easy access to the steering head screws.

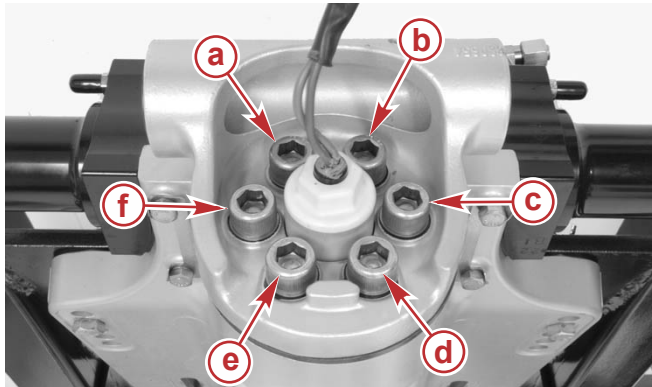
63391

- a** - Front steering head screw
- b** - Front steering head screw
- c** - Rear steering head screw
- d** - Rear steering head screw
- e** - Rear steering head screw
- f** - Rear steering head screw

(a)-(d)	Torque pair
(b)-(e)	Torque pair
(c)-(f)	Torque pair

2. Check the torque on the rear steering head screws. The steering head screws are tightened at the factory to the proper torque in pairs across from each other.

IMPORTANT: If any of the rear steering head screws are not at the correct torque, all of the steering head screws must be properly tightened to the specified torque.

NOTE: If the rear four steering head screws are found to be tightened to the proper torque and not loose, then there is no need to check the front two steering head screws.

Description	Nm	lb-in.	lb-ft
Steering head screw	122	-	90

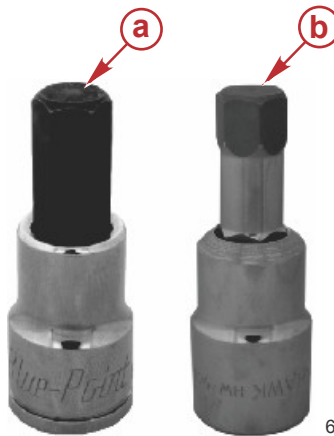
63409

NOTE: Access to the front steering head screws is limited due to interference with the tilt pin.

- a** - Standard 12 mm hex tool
- b** - Modified 12 mm hex tool

- To be able to gain access to the front two steering head screws, a modification to a 12 mm hex tool must be made or obtained from Mercury to be able to clear the tilt tube.

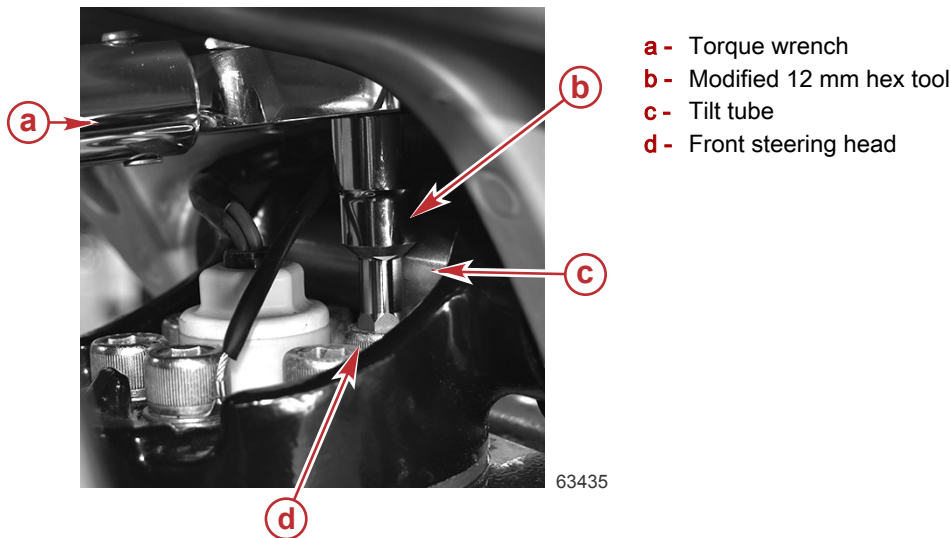
63435

The following image shows the modified 12 mm hex tool with a 1/2" drive torque wrench. The modified 12 mm hex tool is inserted in a front steering head screw and clears the tilt tube.
