## Intermittent Miss at Idle or Slight Hesitation on Acceleration – 70 H.P.

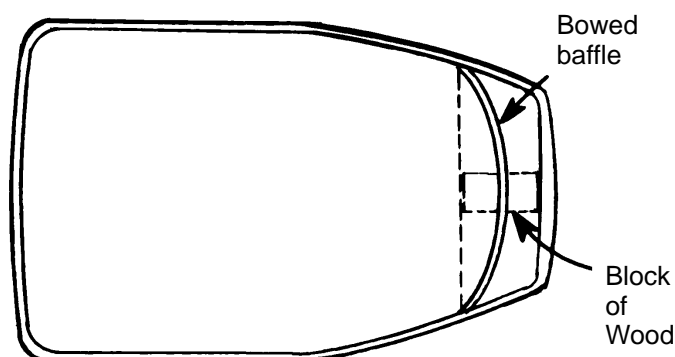
Figure 1.

Engineering has encountered an **unusual** problem with a 70 H.P. engine. After considerable troubleshooting and testing the problem was found. The baffle inside the engine cover was the source of the problem. The baffle was bowed towards the front of the cover (See Figure 1.) causing a problem with fuel distribution to the cylinders. The flywheel always creates a draft inside the engine cover. If the baffle is bowed this draft passes past the front of the carburetor and disrupts the fuel distribution to the cylinders. First check carburetor fuel adjustment for proper mixture setting and test the ignition system for any malfunction. If the above mentioned problem still persists, the top cowl should be suspected as the problem. Use a small block of wood to straighten the baffle. Drill a hole through the baffle, and use a wood screw to secure the block of wood to the baffle. Test run the engine for proper operation. If this corrects the problem replacement of the top cowl will be necessary.
