Special Adjustment for Stator Failures - Sport Jet 90/120

Models Affected

SPORT JET

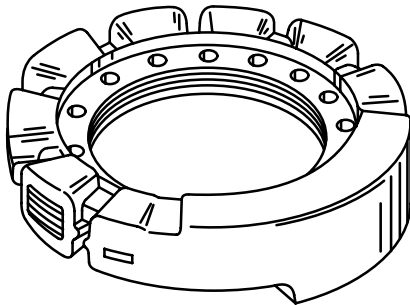
The above listed models have experienced a higher than normal incidence of stator failures. The "red" stator was introduced with design improvements for increased reliability and durability. These models were manufactured prior to the installation of the red stator. If a stator failure occurs within the affected serial number range, Mercury Marine will cover parts and labor for three years from the original outboard date of sale. This applies to first and second owners. The bill of sale must be provided if the consumer is not the registered owner. Both pleasure and commercial use will be covered.

Stator failures will be covered by a special warranty for three years from the original date of sale to assure customer satisfaction.
