Official Notification - Federal Boat Safety Act Sport Jet 90

1993 and 1994 SPORT JET 90

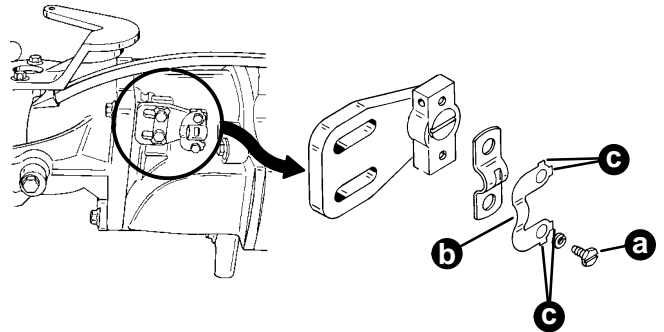
a - Screw (2)
b - Tab Lock- Positioned Toward Reverse Gate
c - Locking Tabs

LOCKING TAB - SHIFT CABLE CLAMP

We have some reports of the shift cable clamp screws loosening. This condition can result in loss of shift control.

1. Install a tab lock, p/n 14-820601, as shown in the figure below with radius portion (b) of the tab lock towards the reverse gate.
2. Torque screws (a) to 50 lb. in. (5.65 N·m).
3. Bend tabs (c) over flats of the screw head.

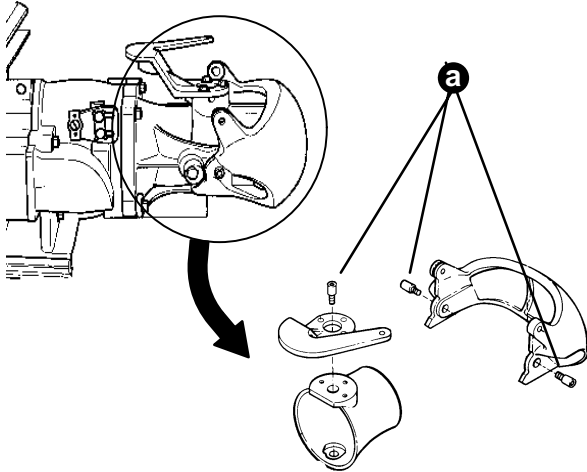
a - Pivot Bolts (3)

PIVOT BOLT - REVERSE GATE

Loose reverse gate pivot bolts have been reported on some pumps. This condition can lead to loss of shift control.

1. Remove three pivot bolts (a) as shown in the figure following.

- Apply Loctite #271 (p/n 92-32609-1) to threads of the pivot bolts.
- Install pivot bolts (a) and torque to 25 lb. ft. (33.89 N·m).

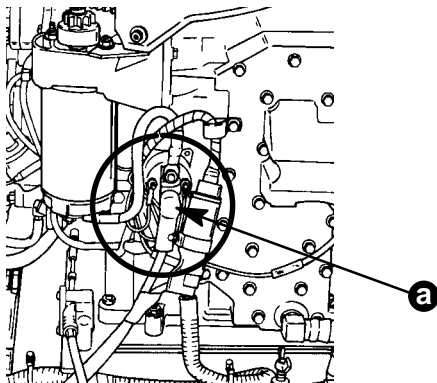
a - Boot, Positive Battery Terminal

**GROUP #3
BOOT - STARTER SOLENOID**

The U.S. Coast Guard recently cited two boat builders who were in violation of regulation #33 CFR 183.445 (b) which requires that the “positive” battery cable connection at the starter solenoid terminal be protected by either a boot (a) or protective shield.

For the convenience of all parties (the consumer, dealer and boat builder), inspect the starter solenoid terminal connection with the “positive” battery cable to see if it is protected with a boot. If it is not, order the boot (p/n 85-79695) and install on the terminal connection of the “positive” battery cable and terminal of the starter solenoid.
