4/5/6 HP FourStroke Laydown Storage Decal

Models Covered	Serial Number
4 HP	0R141172-0R141276
5 HP	0R141277-0R141374
6 HP	0R141375-0R141606

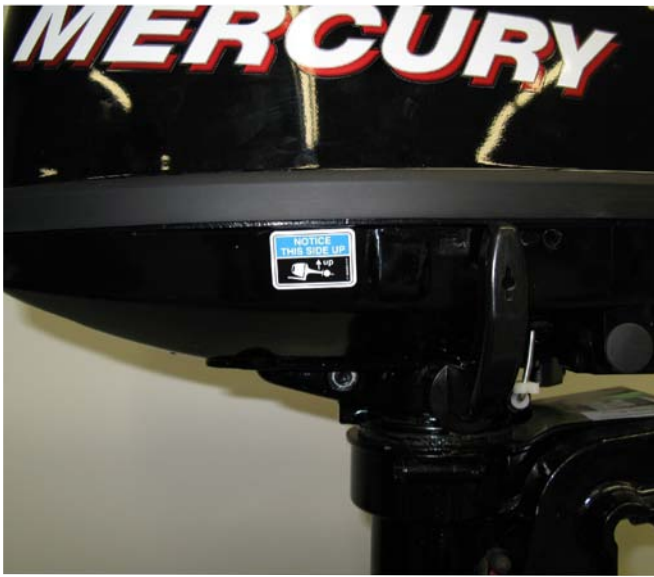
Correct laydown storage decal

NOTE: If the correct laydown storage decal is in place, there is no need to replace the decal.

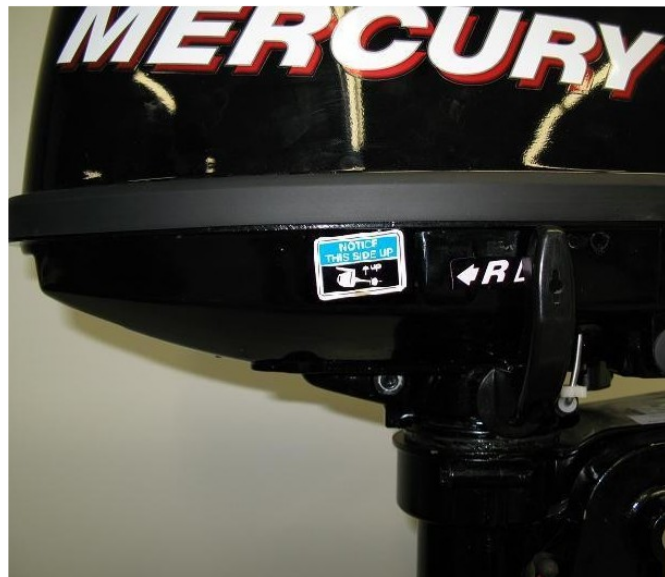
35955

An incorrect laydown storage decal may have been applied to some of the above listed outboards during the manufacturing process. The decal may indicate an incorrect position for laydown storage. This engine is designed for laydown storage with the tiller handle in the down position. If the engine is stored improperly, engine oil may drain from the crankcase and cause engine damage.

Incorrect laydown storage decal

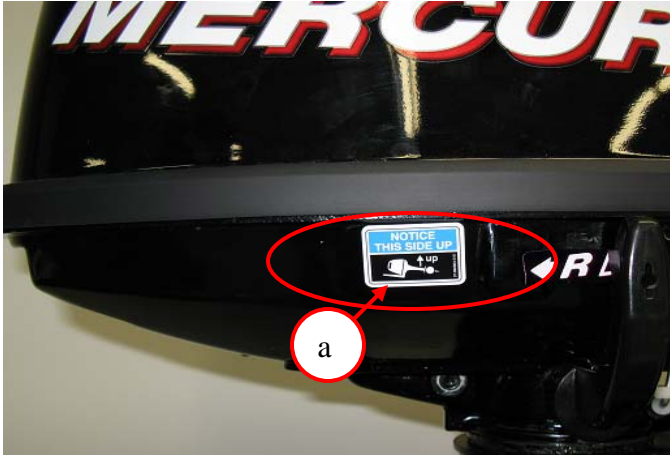
36071

a - Correct laydown storage decal installation. Decal is indicating that laydown storage of the engine should be with the tiller handle in the down position. If the decal is found to be installed in this manner, there is no further action necessary.

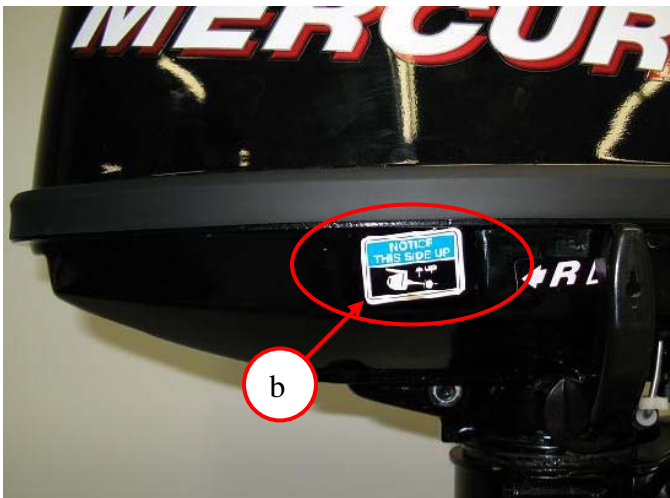
36072

b - Incorrect laydown storage decal. Decal is indicating that laydown storage of the engine should be in the tiller up position, which is incorrect. If decal is found to be installed in this manner, please proceed to step 2.

2. Remove the decal. It may be helpful to use a hair dryer, or to place the engine in direct sunlight to warm the decal and aid in removal of the decal.

3. Clean the surface where the decal was installed. When cleaning the surface, use rubbing alcohol to remove the old adhesive.

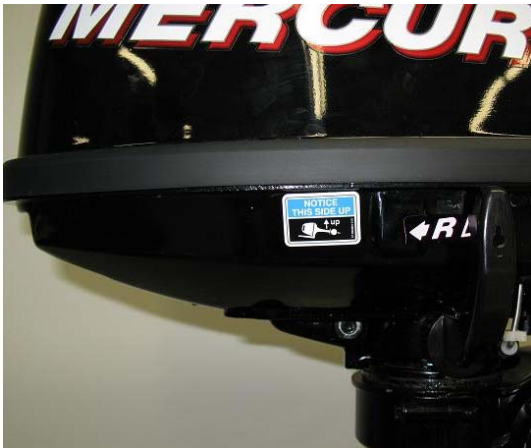
36073

4. Install the decal provided. The replacement decal has a paper backing that should be removed to expose the adhesive surface. The decal should be placed to the left side of the shift handle in the same area as the old decal. Please reference the picture below to aid in decal positioning.
